# **SITE INVESTIGATION**

## **JAMES MATTEO & SONS, INC. SITE WEST DEPTFORD TWP., GLOUCESTER COUNTY**

# PRELIMINARY ASSESSMENT AND SITE INVESTIGATION REPORT

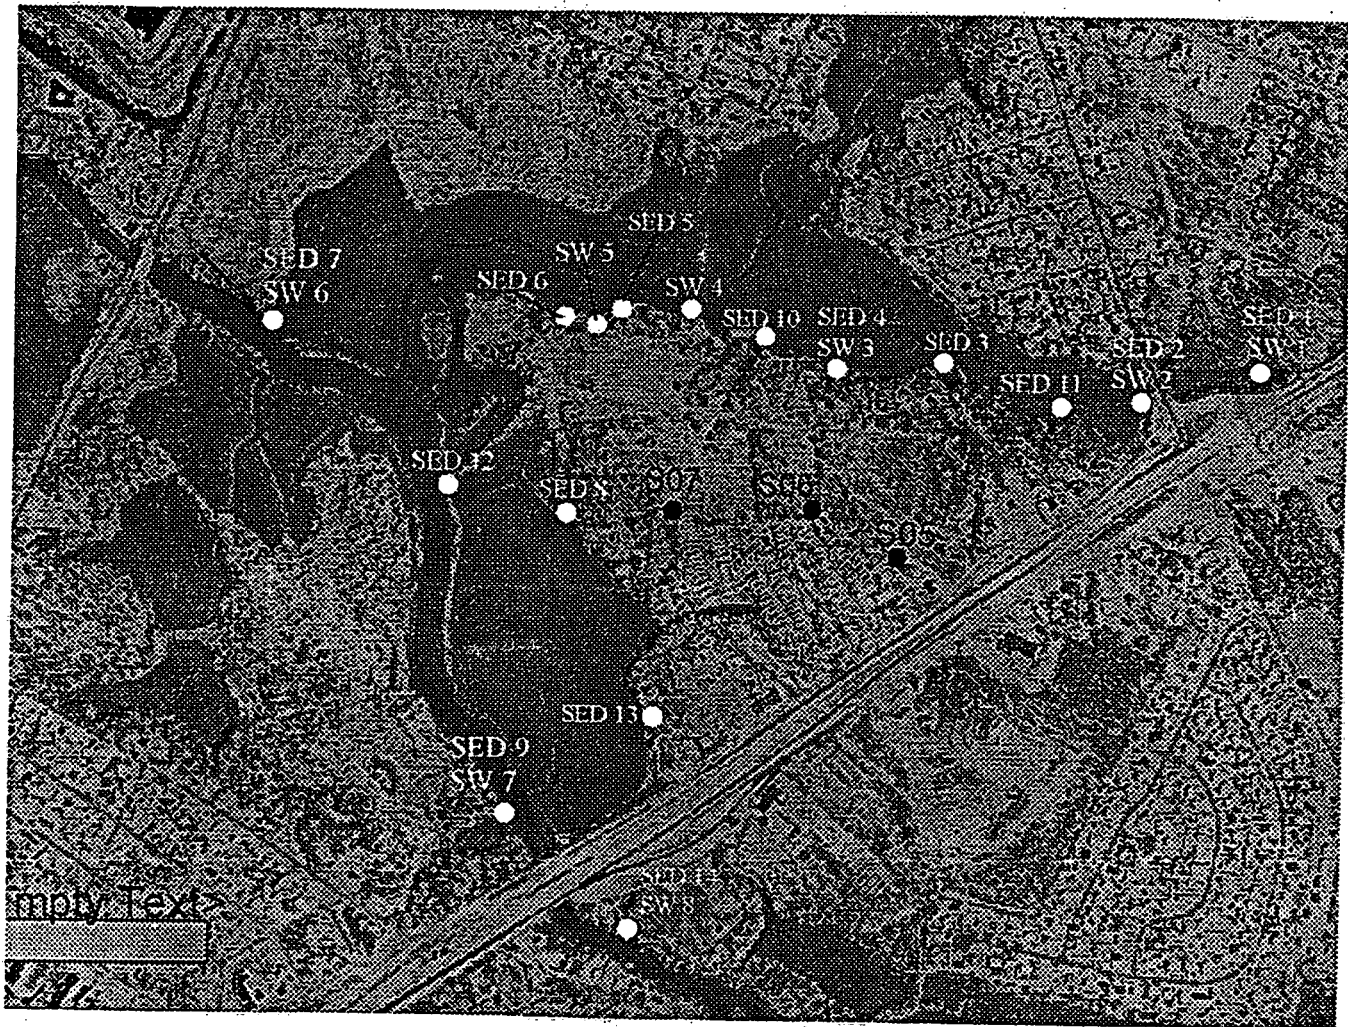
# MATTEO SAMPLE MAP

- soil background sample
- sediment + surface water sample

The following tables summarize data points which exceed an applicable NJDEP Soil Cleanup Criteria (SCC) for residential areas. All data are expressed in parts per million and all depths are in feet. All Sampling locations can be found on Map 2. The abbreviation TPH stands for total petroleum hydrocarbons.

On the dates noted on the tables above, NJDEP conducted sampling at the site. All sampling locations can be viewed on Map 2. Since a resident population does not exist with regard to this site, determinations regarding Level 1 or Level 2 are not required.

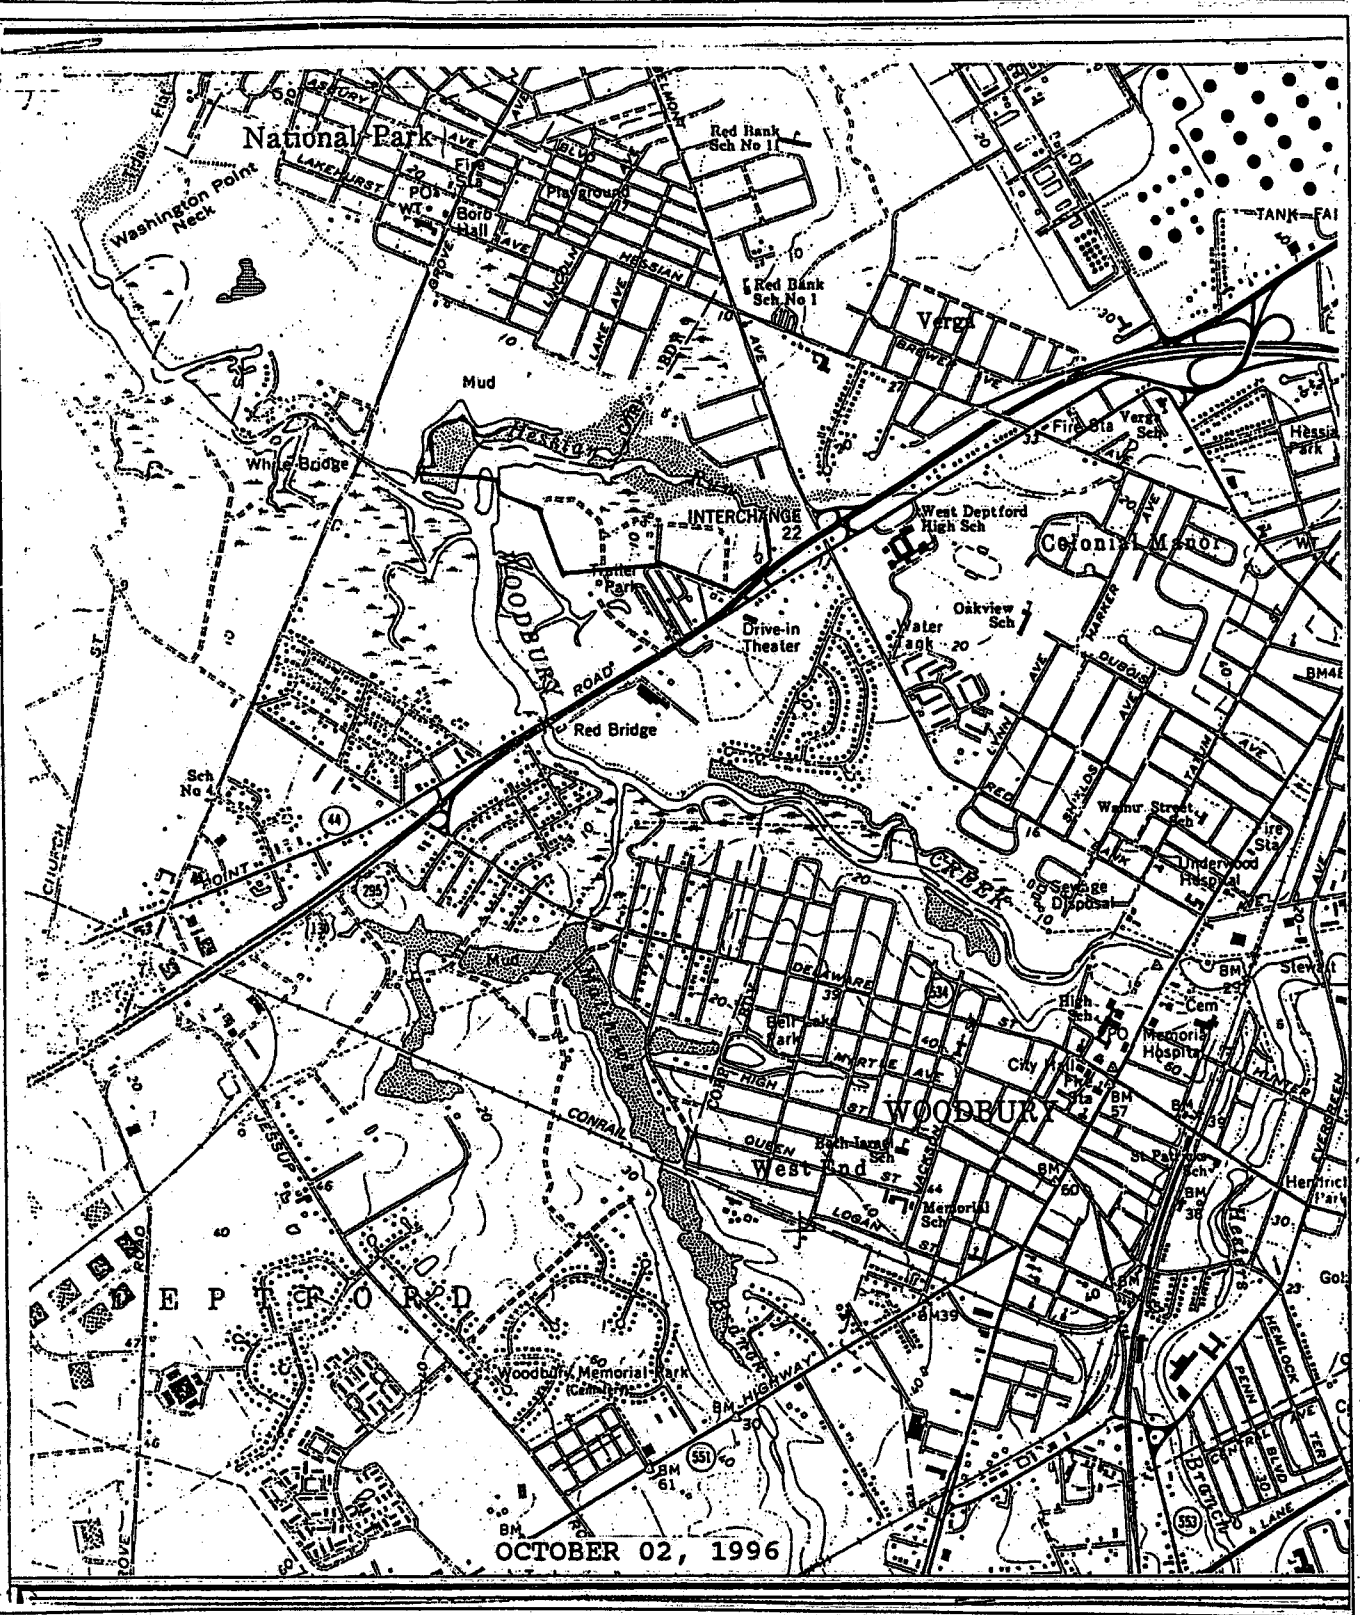
MAP 1 - USGS TOPOGRAPHIC MAP - WOODBURY QUADRANGLE

JAMES MATTEO AND SONS, INC 1708 Route 130, West Deptford NJ 08086  
 Gloucester County Latitude: 39° 51' 20" Longitude: 75° 10' 15" (1986)

An estimate of 250 homes within 0.25 to 0.5 miles from the site was made based upon a review of Map 1. Assuming at least 2 people in each home, there would be approximately 500 people in the noted distance interval. (Attachment XX, Map 1)

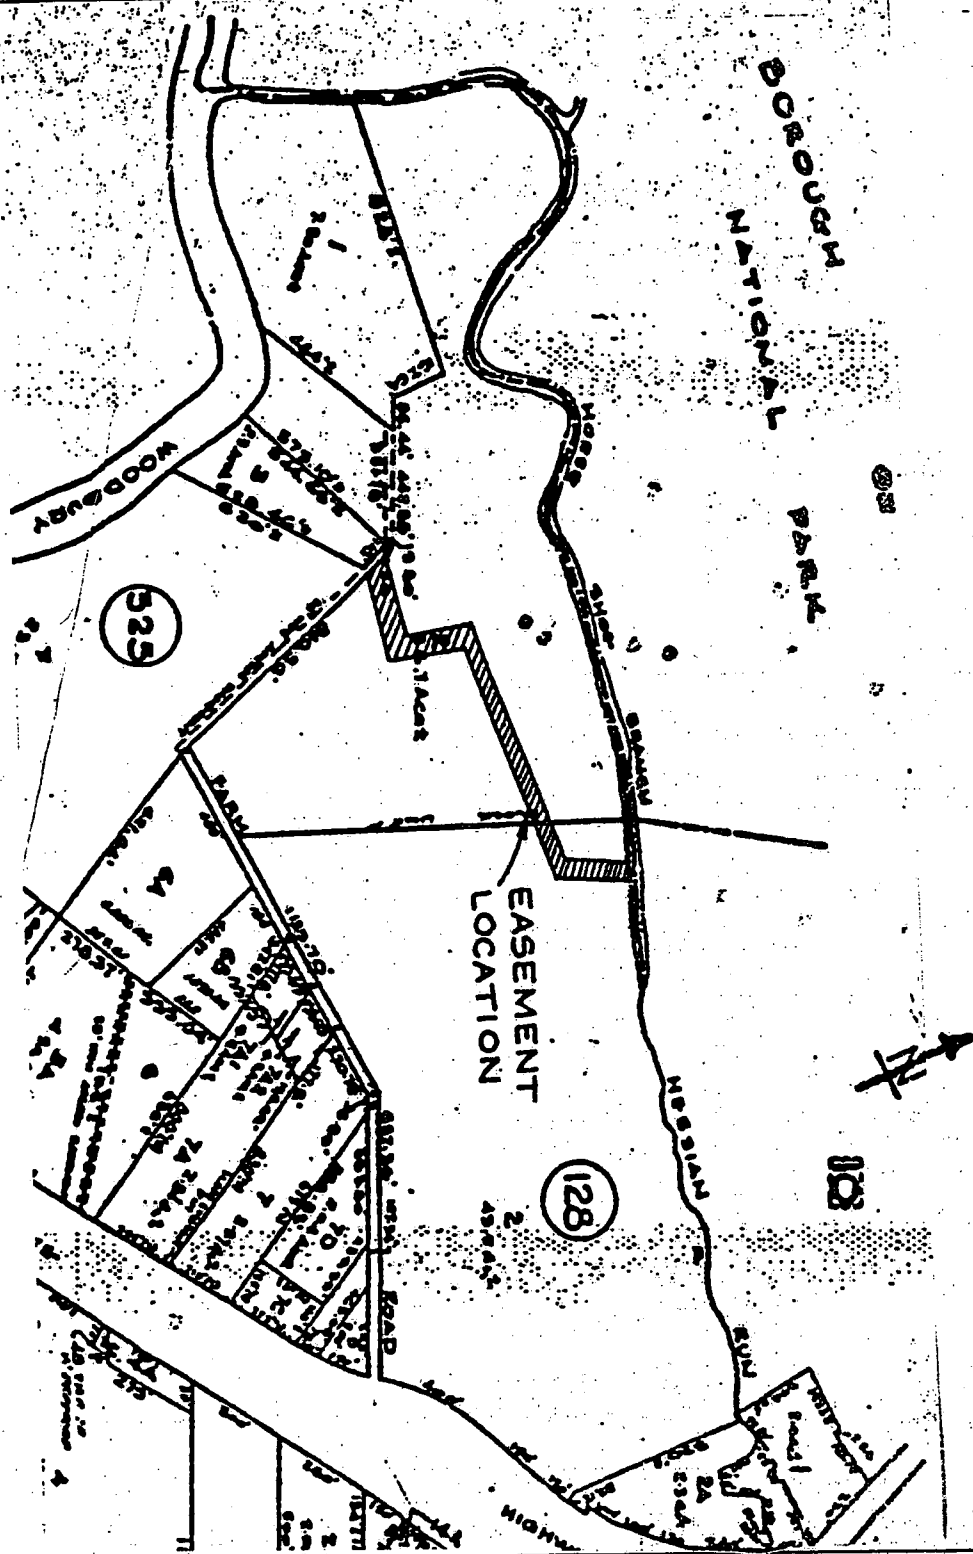
MAP 3 - TAX MAP

JAMES MATTEO AND SONS SITE, WEST DEPTFORD TOWNSHIP

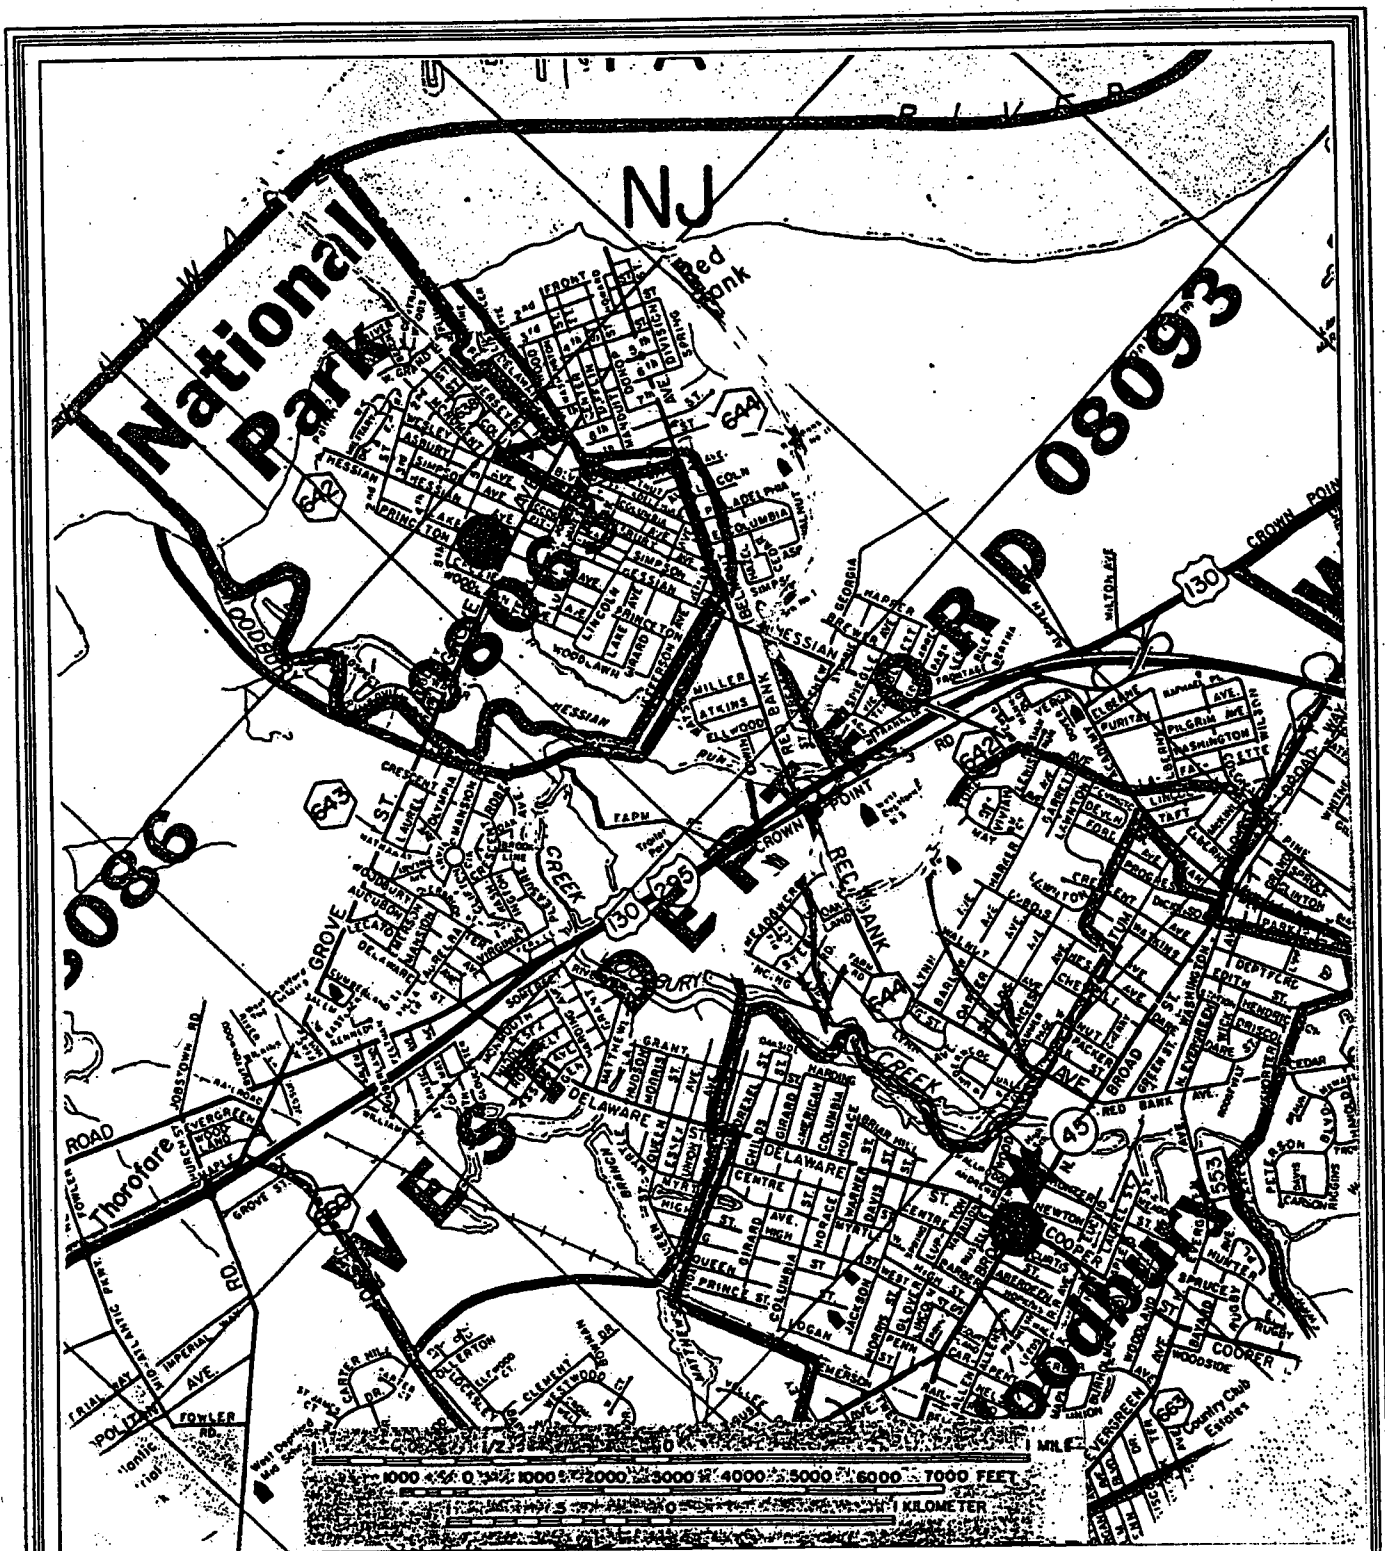
MAP CREATED OCTOBER 02, 1996  
 MAP SOURCE: ALFRED PATTON MAP OF GLOUCESTER COUNTY  
 MAP 4 - ROAD MAP

# **JAMES MATTEO AND SONS SITE, WEST DEPTFORD TOWNSHIP**

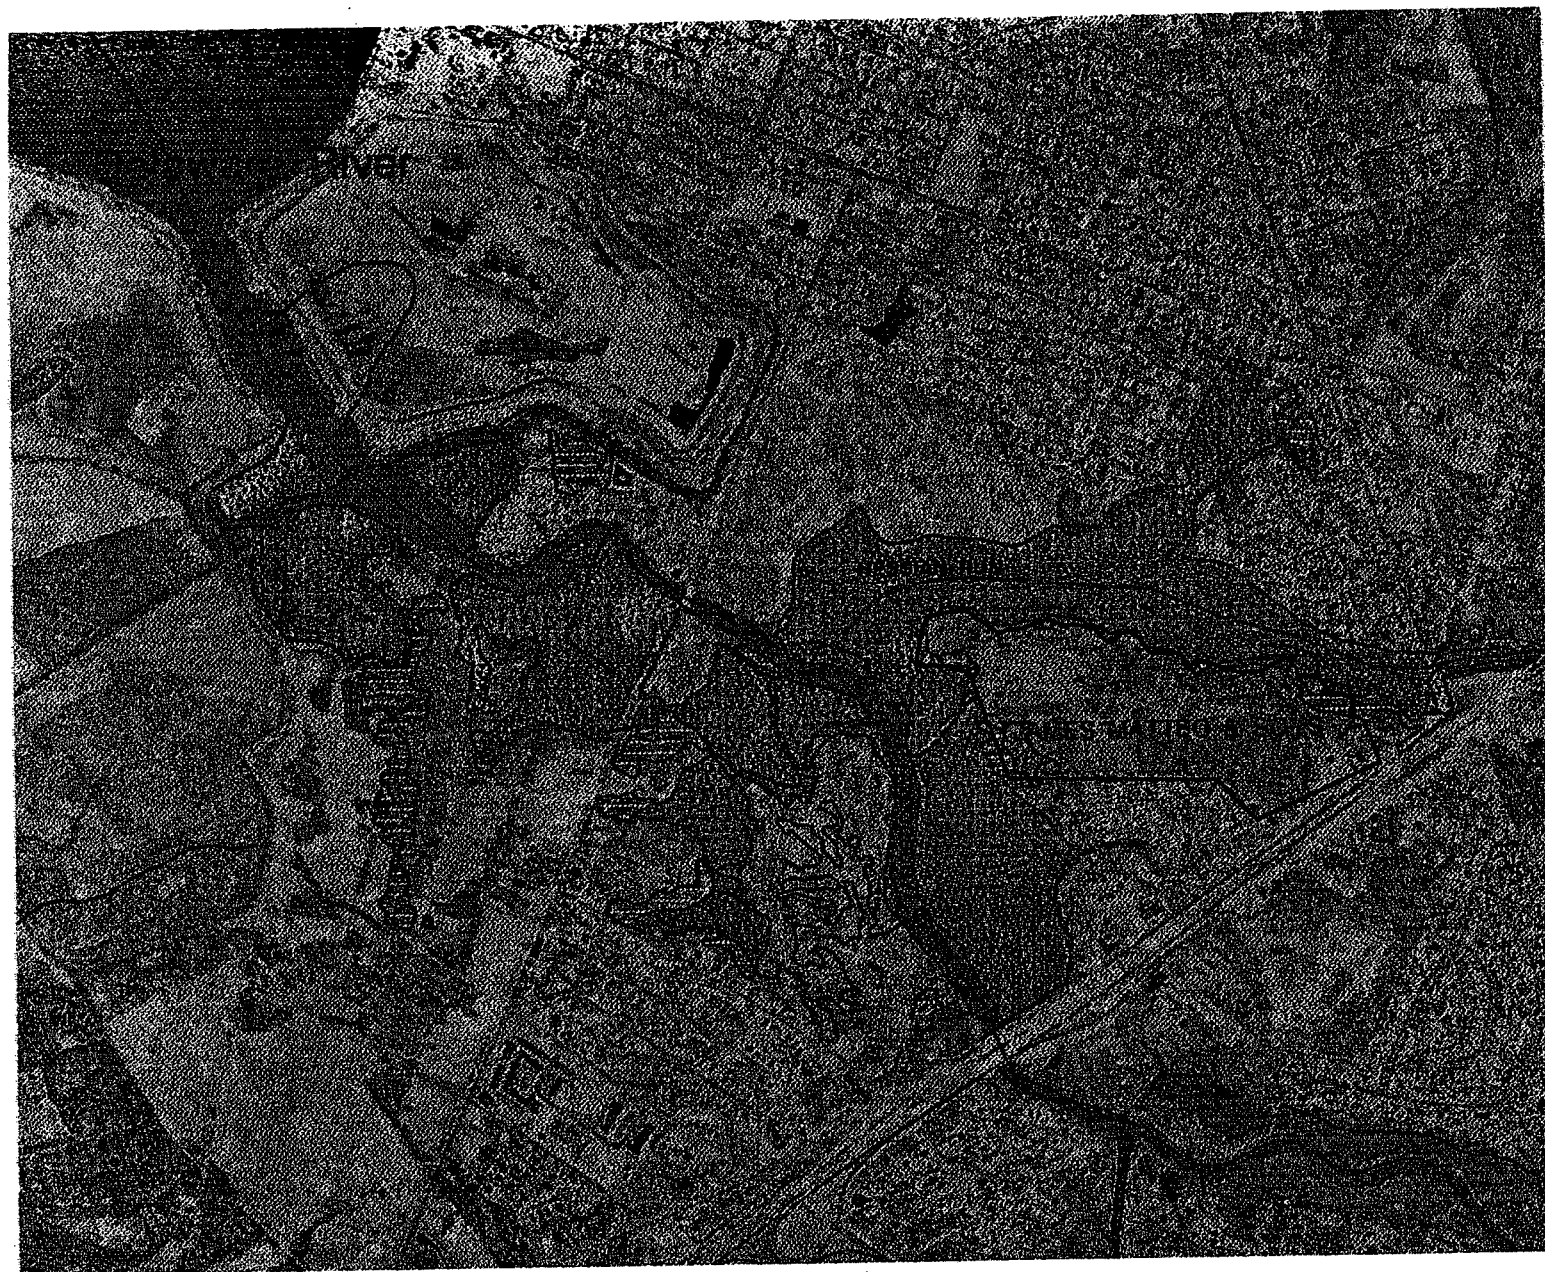
**Map 6  
Wetlands Map**

- Site Boundary
- Surface Water
- Wetland Types**
- DECIDUOUS SCRUB/SHRUB WETLANDS
- DECIDUOUS WOODED WETLANDS
- FRESHWATER TIDAL MARSHES
- HERBACEOUS WETLANDS
